Comparative OBSI Testing in Northern California: The Davis Rodeo

Authors:
Paul R. Donovan, Sc.D.

Part of Partnered Pavement Research Program (PPRC) Strategic Plan Element 4.39:
Continued Monitoring of Selected Quieter Pavement Test Sections

Illingworth & Rodkin, Inc.
Petaluma, CA

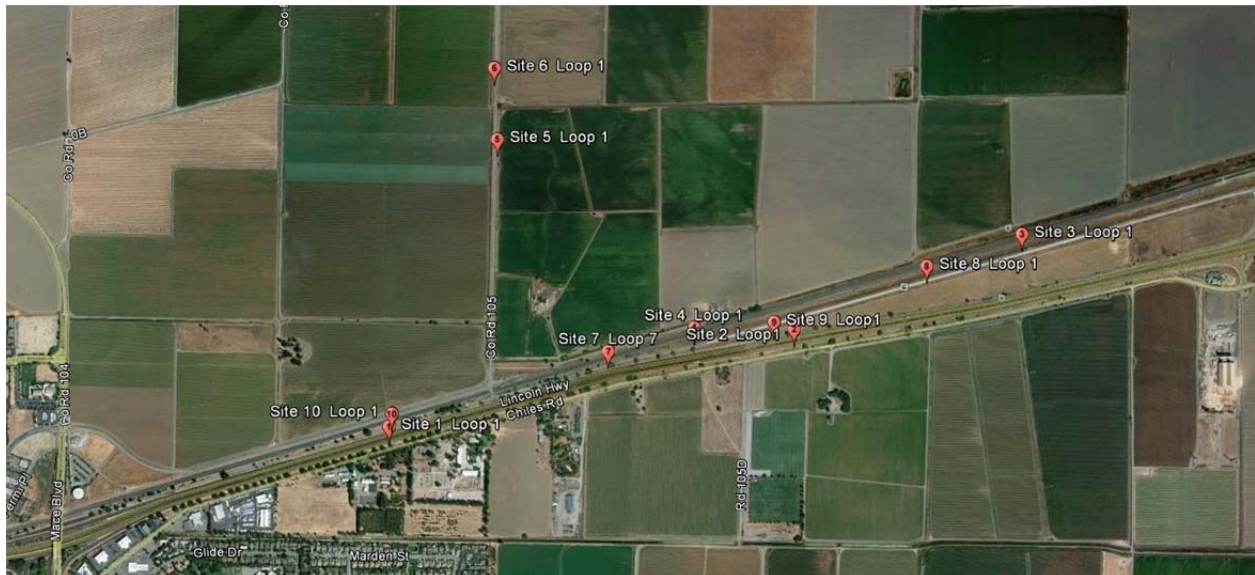
Figure 1: Location of test sites on Rodeo Loop 1

The sites were grouped into two loops with the intent that the testing at each loop would be completed simultaneously by all three teams before moving to the next loop. The locations of the sites in Loop 1 are shown in Figure 1. Several of these sites have been used in previous comparative testing including 2, 3, 5, 6, 8, and 9. In addition, sites 3, 5, 6, and 8 have been routinely used by PRC for on-going calibration. Specific information on each site in Loop 1 is

provided in Table 1. The length of Loop 1 was 12.9 miles resulting in an approximate test time of 15 minutes per circuit given stops and turnarounds. The loop began at the Mace Road

entrance onto I-80, followed I-80 eastbound to the Chiles Road exit which loops around to westbound County Road (Co) 32, proceeds northbound on Co 105 past Site 5. After a turnaround farther up Co Rd 105, the loop proceeds southbound to Co Rd 32 eastbound and back on to westbound I-80 to the Mace Road exit.

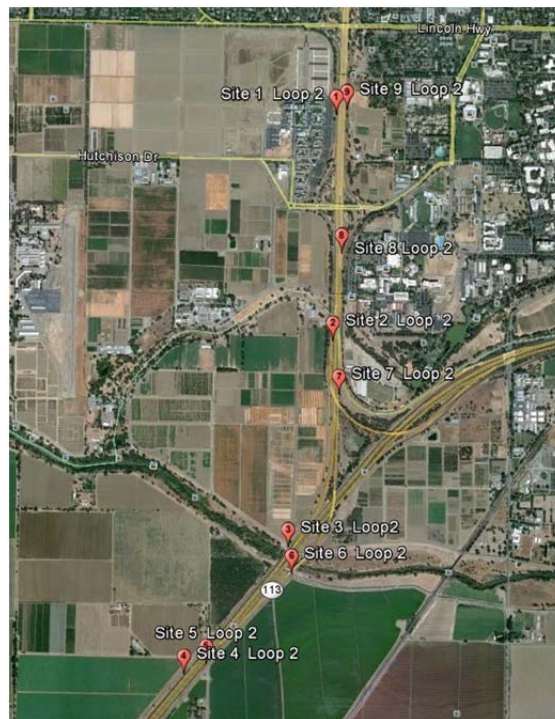
Figure 2: Location of test sites on Rodeo Loop 2

The nine test sites on Loop 2 are shown in Figure 2. This loop is approximately 6.8 miles in

length and can be traversed in about 9 minutes with turnarounds. Information on these sites is provided in Table 2. This loop begins southbound on State Route (SR) 113 from the Lincoln

Highway ramp, proceeds southbound exiting on to westbound I-80, proceeds on I-80 to the Kidwell Road exit used as a turnaround to eastbound I-80. After two sites on eastbound I-80, the loop follows northbound SR 113 back to the Lincoln Highway exit for a turnaround back onto the loop.

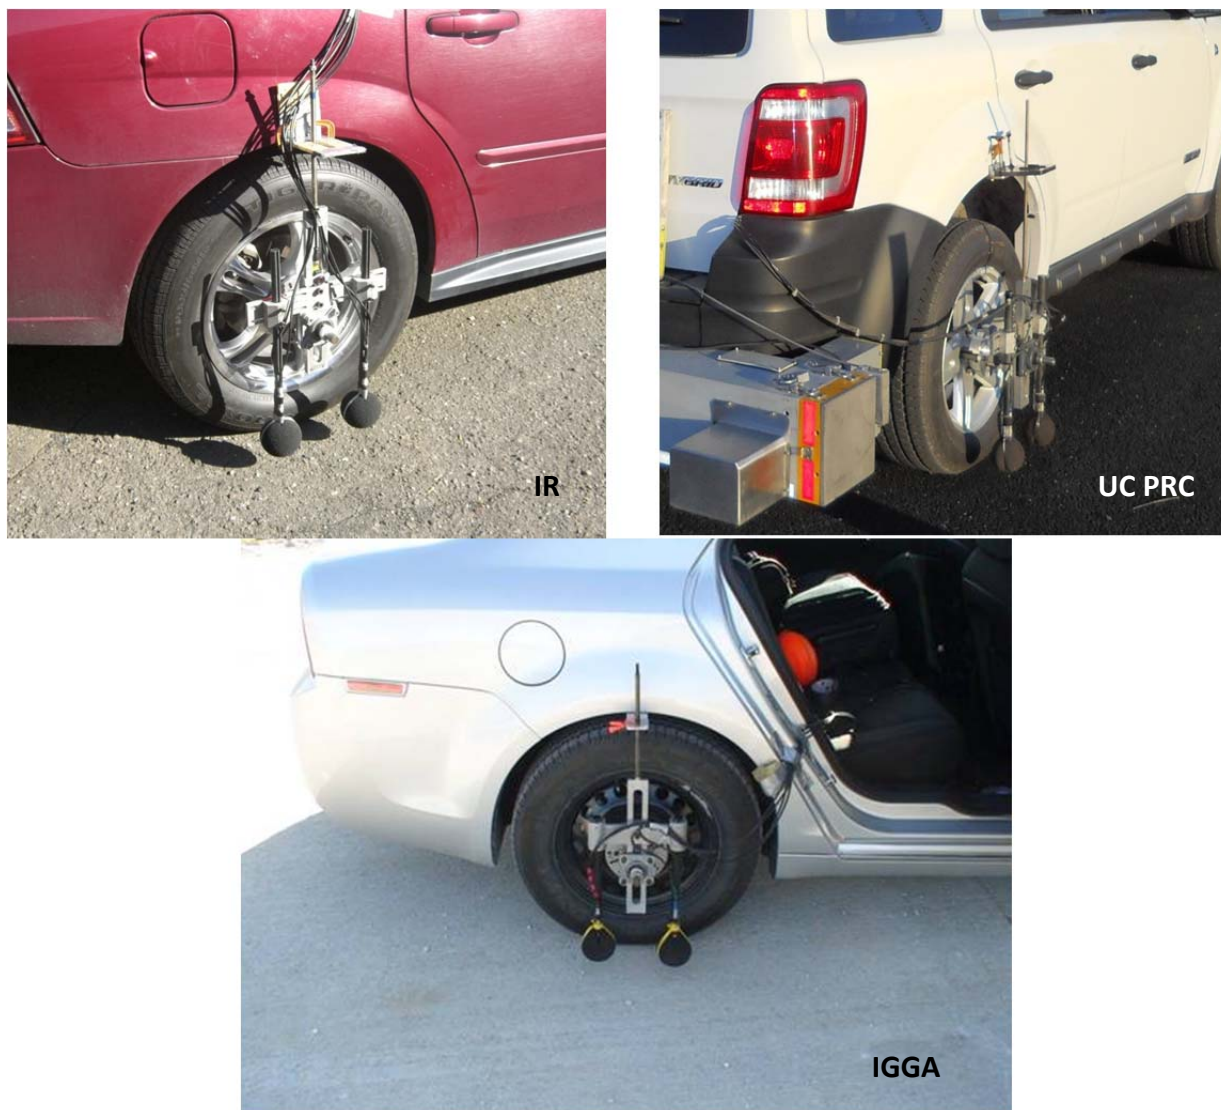
Figure 3: OBSI fixtures on IR, UC PRC, and IGGA test vehicle

All three teams used similar OBSI fixtures, microphones, and preamplifiers to acquire the sound pressure signals needed to measure sound intensity. These are shown mounted on test vehicles for each team in Figure 3. Each team did use different analyzers to process the signals into sound intensity levels. IGGA uses a five-channel Brüel & Kjaer PULSE system to produce the leading and trailing edge probe signals into sound intensity levels. PRC uses a four-channel Harmonie box built into a Soundbook computer as produced by Sinus Messtechnik GmbH. IR uses a National Instruments (NI) analogue to digital converter to acquire four signals and processes these in a laptop computer using LabView software to obtain the sound intensity levels. This NI system also uses an external four-channel G.R.A.S. microphone power supply that in turn feeds into the computer. Prior to the on-road measurements, a bench-top comparison of the data acquisition/processing systems was completed using a G.R.A.S. Type 51AB Intensity Calibrator and the differences between systems was found to be negligible.

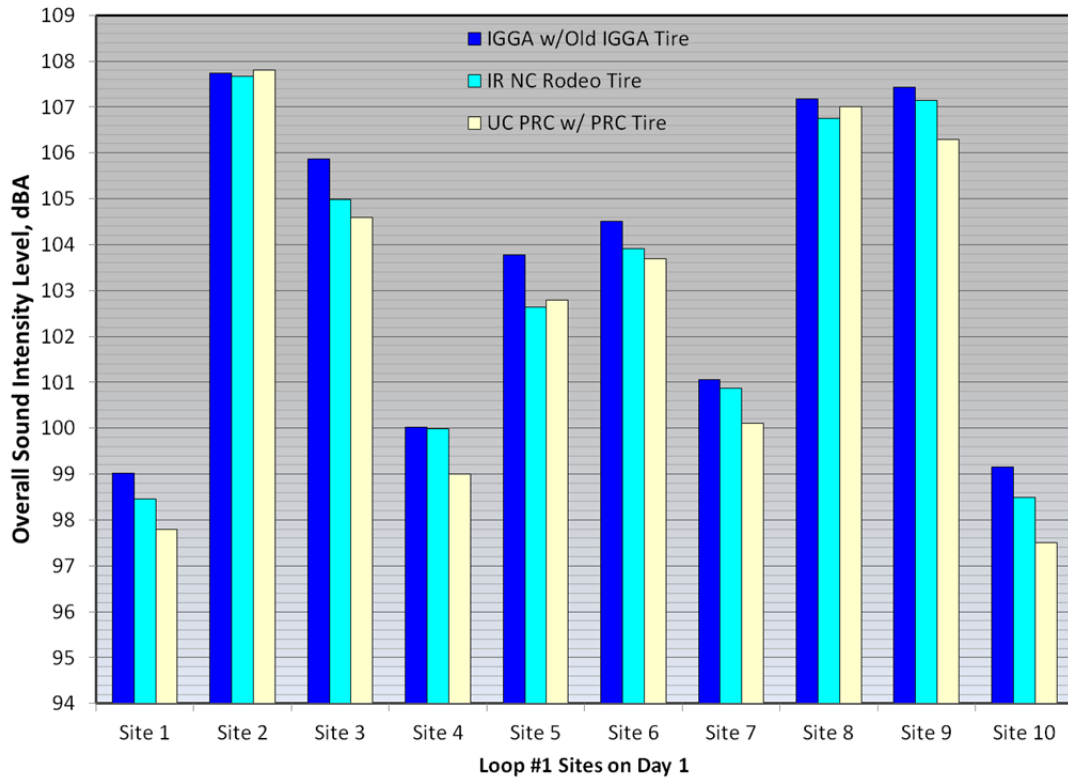
Figure 4: Overall OBSI levels for all teams on Loop 1 measured October 10th

The overall OBSI levels measured on October 10th for Loop 1 are shown in Figure 4. For these sites, the UC PRC results are typically lower than the other teams with the average difference being 0.4 dB lower than IR and 0.9 dB lower than IGGA. The range in OBSI levels between the teams was calculated on each site. The maximum range was found to be 1.7 dB and average range for all sites was 1.0 dB with a standard deviation of 0.5 dB. For the Loop 2 results in Figure 5, the levels for the UC PRC tend to be slightly higher than the other two although there is some variation in the rank ordering of the teams between the different pavements. For Loop 2, the UC PRC levels average 0.4 dB higher than IGGA and 0.8 dB higher than IR. For these data, the maximum range was 1.7 dB while the average range was 1.1 dB with a standard deviation of 0.5 dB. Since the two loops were measured at almost the same air temperature, they can be

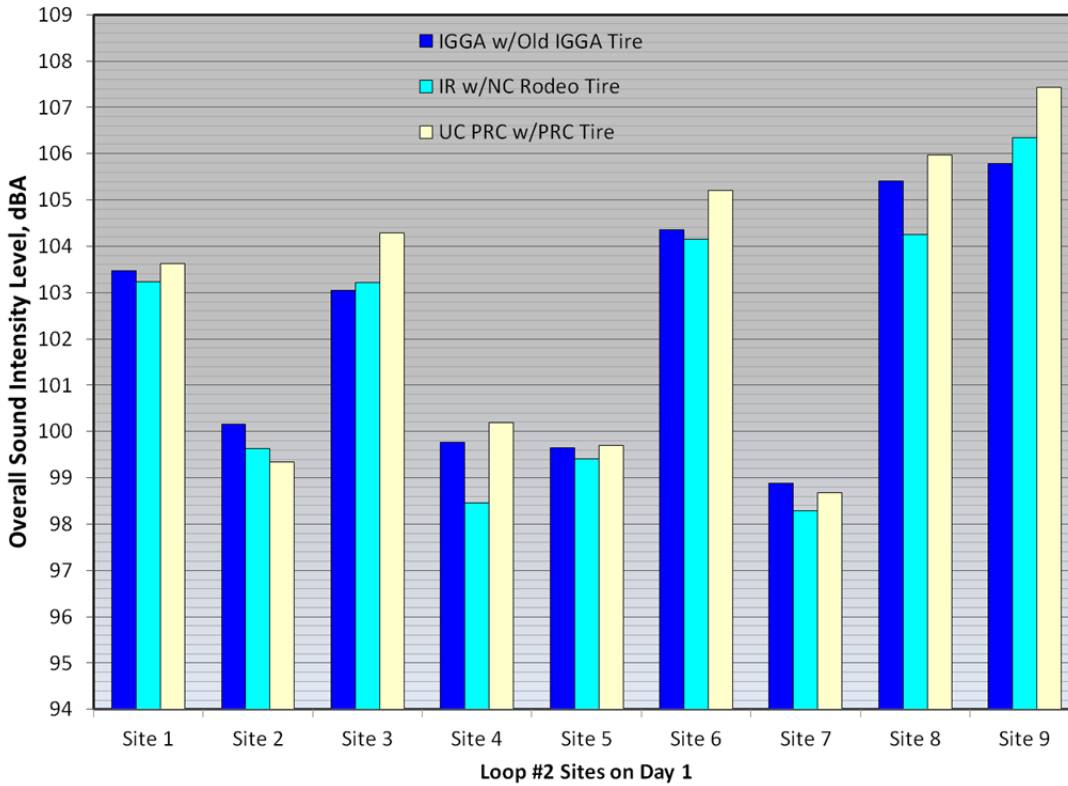
Figure 5: Overall OBSI levels for all teams on Loop 2 measured October 10th

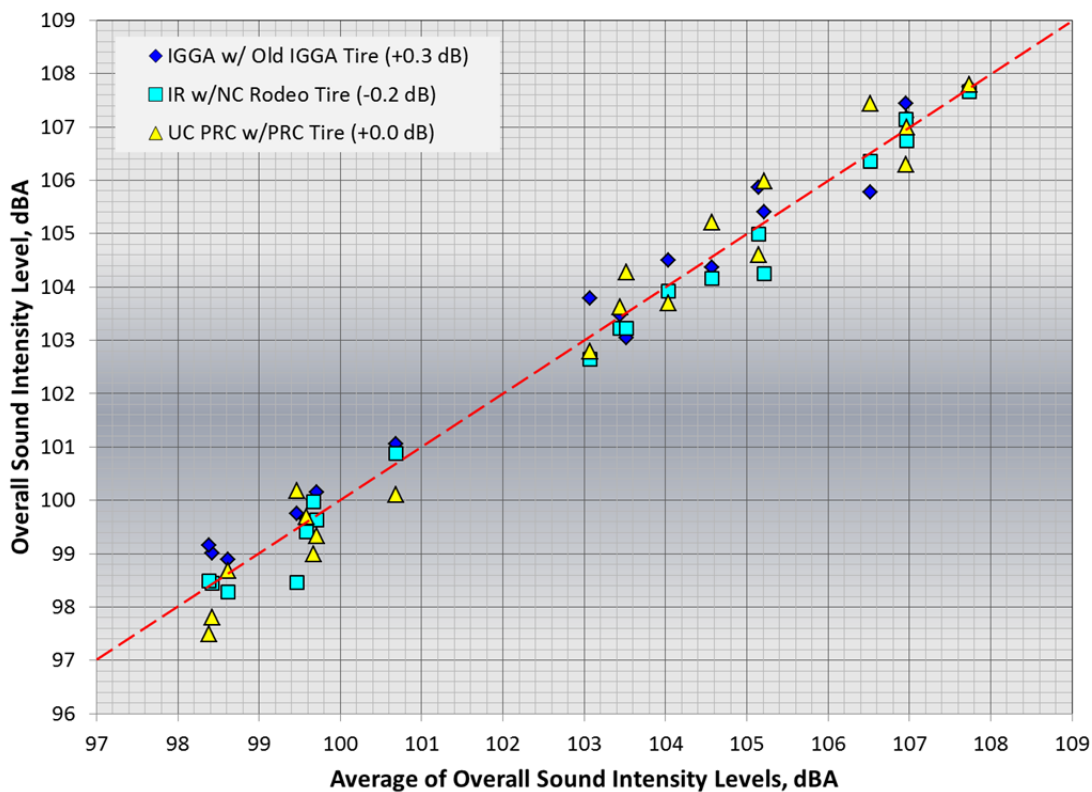
Figure 6: Plot of overall OBSI levels for each team vs. the average of teams at each test site

combined to consider directly the statistics of both data sets. The results from the two loops are plotted in Figure 6 in which the individual data points are plotted against the average of the three teams for each measurement site. Compared to the average of all teams, the average for the UC

PRC levels is equal to the average of all teams while the IR average is 0.2 dB less and the IGGA average is 0.3 dB greater for a total range of 0.5 dB. The statistics for combined loops of this Davis Rodeo are compared to previous rodeos [3] in Table 5. The average difference or average range for the Davis Rodeo was lower than the previous rodeos by 0.2 dB to 0.5 dB. The standard deviation is similar to the others and maximum range is lower by 0.3 to 1.2 dB. The statistics are also well within the range of precision and bias statements of the TP 76 procedure.

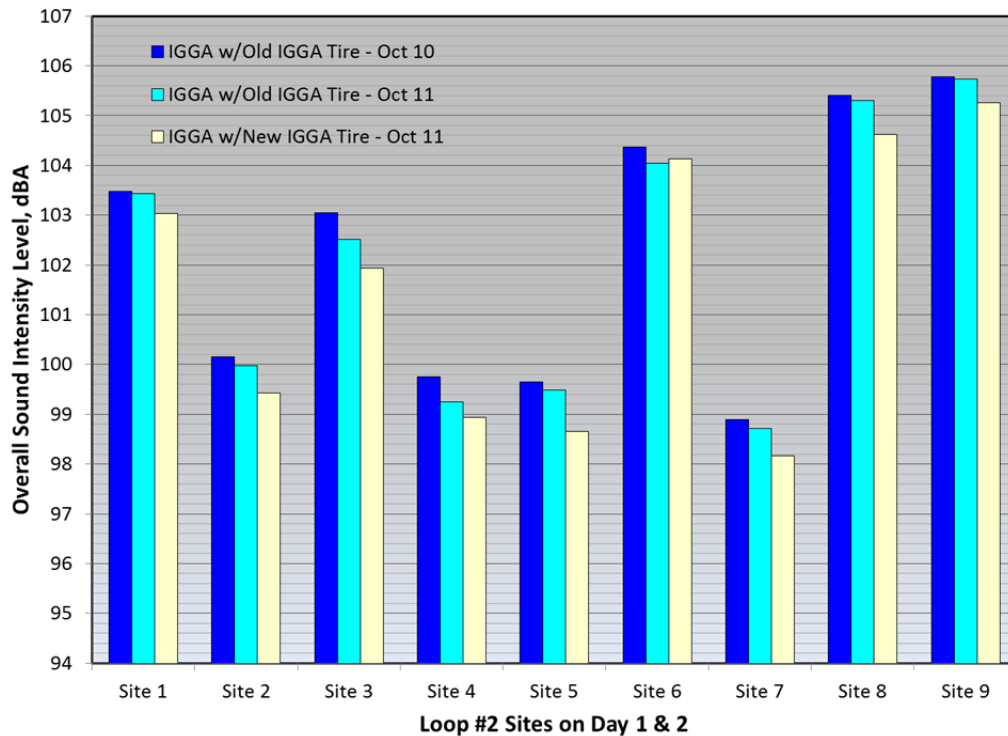
Figure 7: Overall OBSI levels for new and old IGGA tires tested on the IGGA vehicle

From Table 4, the temperatures on October 11th were about 10 to 18°F cooler than the day before. From the temperature gradient of -0.04 dB/°F, the measured levels for the same tire would be about 0.4 to 0.7 dB higher on October 11th. From the results shown in Figure 7 for the IGGA testing on both days, the levels on the warmer day are actually slightly higher averaging about 0.2 dB higher. Data for the two-day comparison were not normalized for temperature for two reasons: normalizing the temperatures for these pavements did not improve the results, and the change in temperature was relatively small. Figure 7 also provides a comparison of the old IGGA tire and new(er) IGGA tire on October 11th with a temperature difference of only 7° F. As would be expected from the data of Table 3, the levels for the newer tire were slightly lower

(0.5 dB) than the older tire. This is consistent with the finding from the NCHRP Project 1-44-1 in which older tires as a group were found to average 0.4 dB higher in level than the average of a group of new tires. In the NCHRP study, it was also determined that OBSI level increases at rate of 0.055dB/hardness number. With the hardness number difference of 8 for the old and new IGGA tires, the expected increase would be 0.4 dB which compares well to the measured increase from this rodeo. The decreased tread depth of the Old IGGA tire could also contribute slightly (less than 0.1 dB) to the higher noise levels as decreasing tread depth is expected to increase overall level by 0.106 dB/mm [2]. This same tire comparison was made on the IR vehicle on October 11th producing a somewhat different result. Without taking temperature into account, the newer tire was measured to be 0.1 dB higher than the older tire. When temperature was taken into account, this trend was reversed with the older tire being 0.2 dB higher in level. Accounting for temperature, this trend is reversed with the older tire being 0.2 dB higher in level. The levels measured with the IR test vehicle were also higher than those measured on the IGGA vehicle for the respective tests measured on October 11th with an average difference for the old tire of 0.5 dB and 1.1 dB for the newer tire.

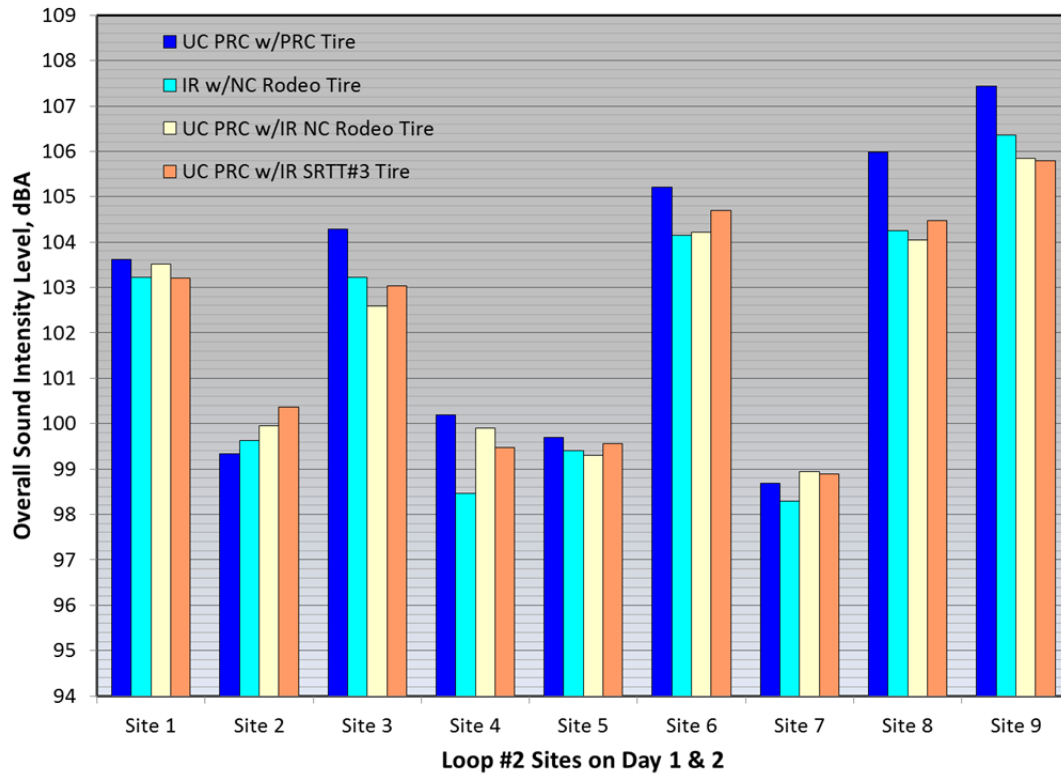
Figure 8: Overall OBSI levels measured on UC PRC & IR test vehicles

Several more comparisons are shown in Figure 8 which includes all of the data from for UC PRC vehicle and results for the NC Rodeo tire tested on both the IR and UC PRC vehicles. As with

the results in general, these data vary in rank ordering with pavement, for example, Site 2 shows the opposite rank order of the tires/vehicles on Site 9. In general, the UC PRC tire on the UC PRC vehicle tends to produce higher levels than the other cases. Considering the UC PRC vehicle only, the UC PRC tire is 0.7 dB and 0.5 dB higher than the NC Rodeo tire and SRTT #3 respectively. From Table 3, this is not unexpected as the NC tire and SRTT #3 have lower hardness numbers than the UC PRC tire and more tread depth. Even though the PRC tire is newer, its accumulated mileage is greater than the other tires. In comparing the NC Rodeo tire measured on the IR and UC PRC vehicles, the levels are very similar with an average difference of only 0.1 dB. This further supports a conclusion that differences seen between the PRC tire and the other cases is due primarily to the tire itself rather than any vehicle or test team biases.

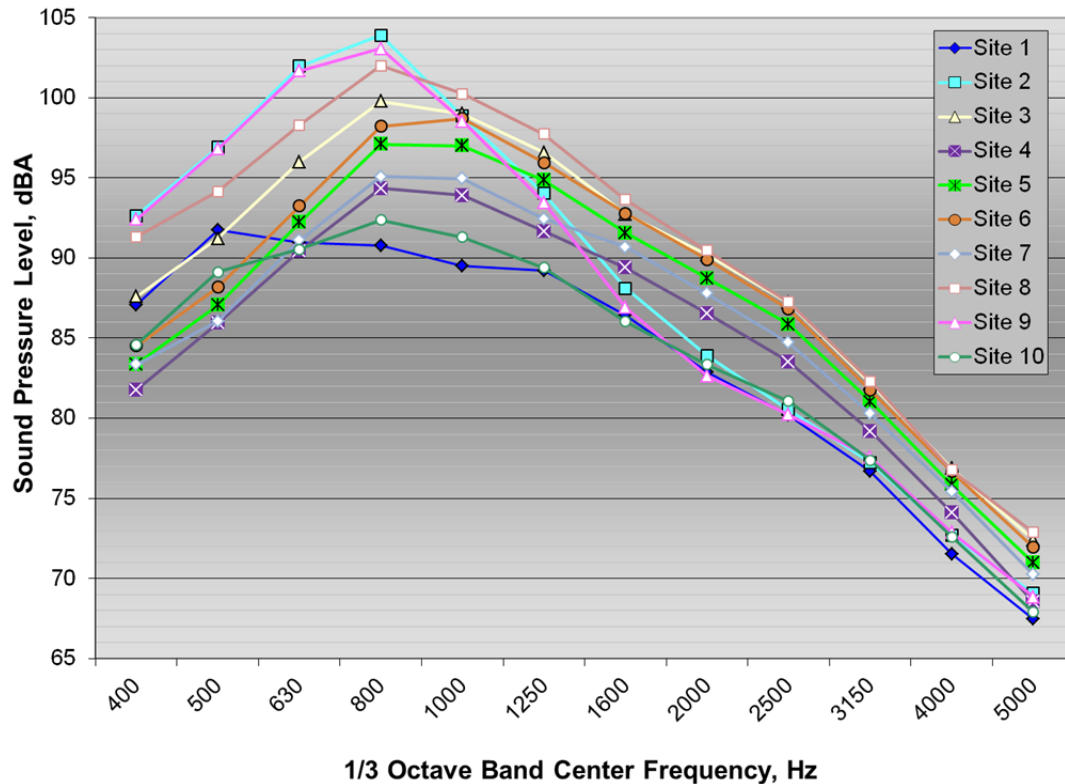
Figure 9: 1/3 octave band levels for Loop 1 measured by IR test car with the NC Rodeo tire

The one-third octave band spectra for all ten measurement sites in Loop 1 are shown in Figure 9 as measured by IR with the NC Rodeo tire. As suggested by the range of the overall OBSI

levels, there is also a considerable range in level between the sites on a one-third octave band basis. Below 1250 Hz, the differences range from about 10 dB to 13 dB. In the higher frequencies, the differences are smaller, but still range between 5 dB and 8 dB. For Loop 2, the differences are slightly smaller with the range below 2500 Hz being about 8 dB while the higher frequency range is about the same as the Loop 1 sites. For the Loop 2 pavements in shown in Figure 10, there is a definite grouping of the newer AC sites (2, 4, 5, and 7) with the range for these pavements being about 2 dB or less. These pavements are also lower in level by about 5 to 8 dB for bands above 800 Hz.

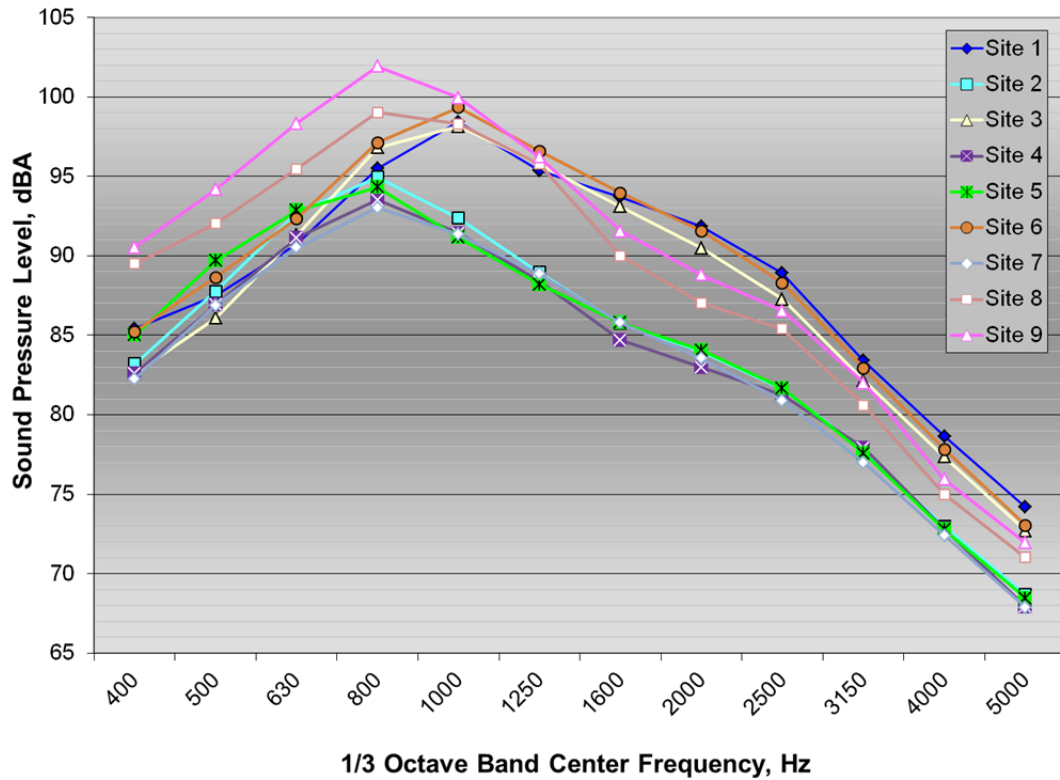
Figure 10: 1/3 octave band levels for Loop 2 measured by IR test car with the NC Rodeo tire

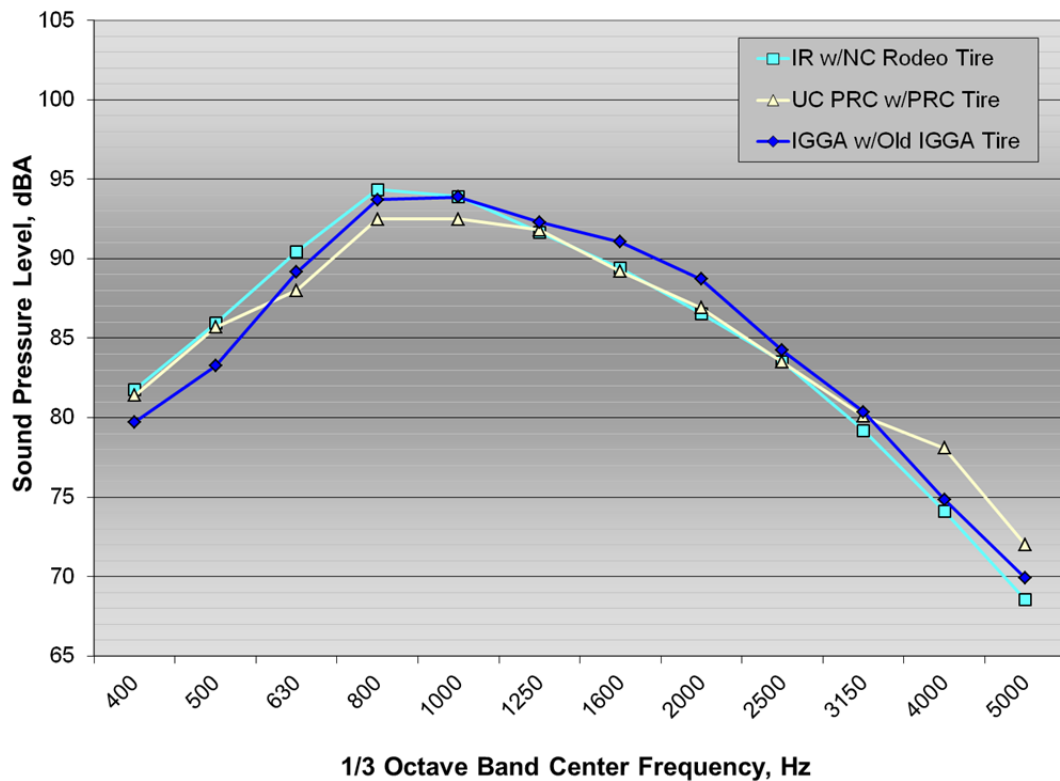
Figure 11: 1/3 octave band levels for all three teams on Site 4 of Loop 1

Comparing the spectra for each team on each pavement indicated that the results are fairly consistent as typified by the results shown in Figure 11. For Loop 1, the average range in one-third octave level is 1.6 dB with a standard deviation of 0.7 dB. For Loop 2, the average range was somewhat larger at 2.0 dB with a standard deviation of 0.9 dB. As general trend, the levels for IGGA data with the Old IGGA tire were higher than the IR and UC PRC results at 800 Hz and above as shown in Figure 12. This same trend is consistently apparent in comparing the spectra for the new and old IGGA tires as exemplified in Figure 13. This is thought to be due to

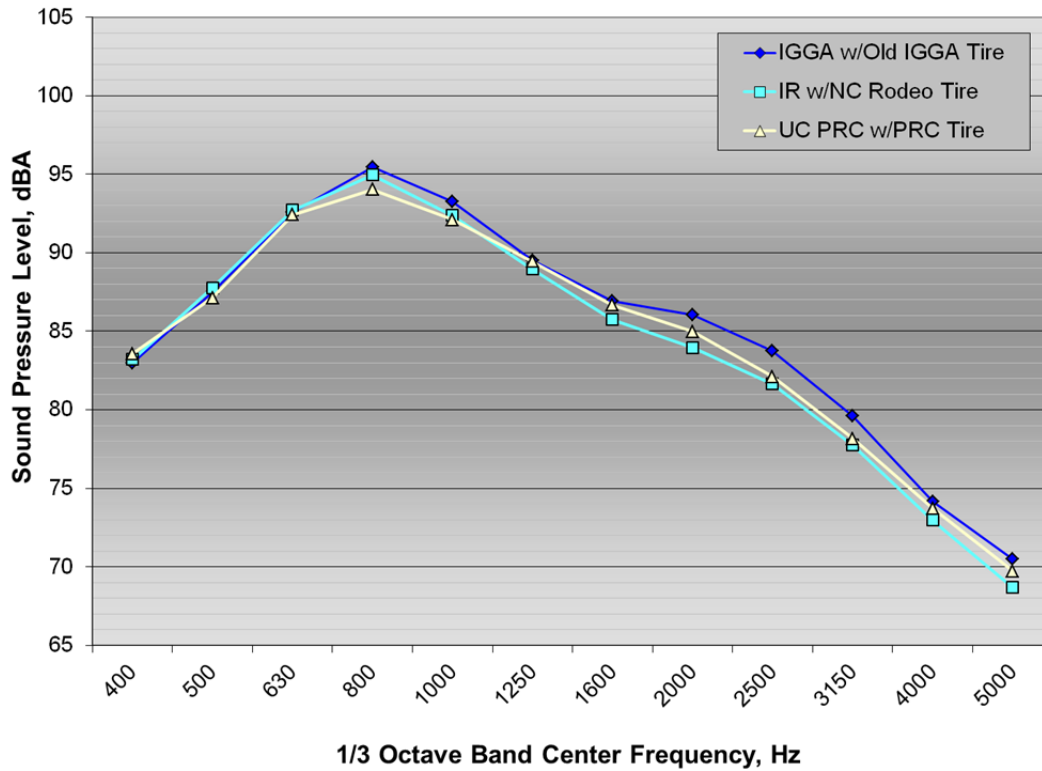
Figure 12: 1/3 octave band levels for all three teams on Site 2 of Loop 2

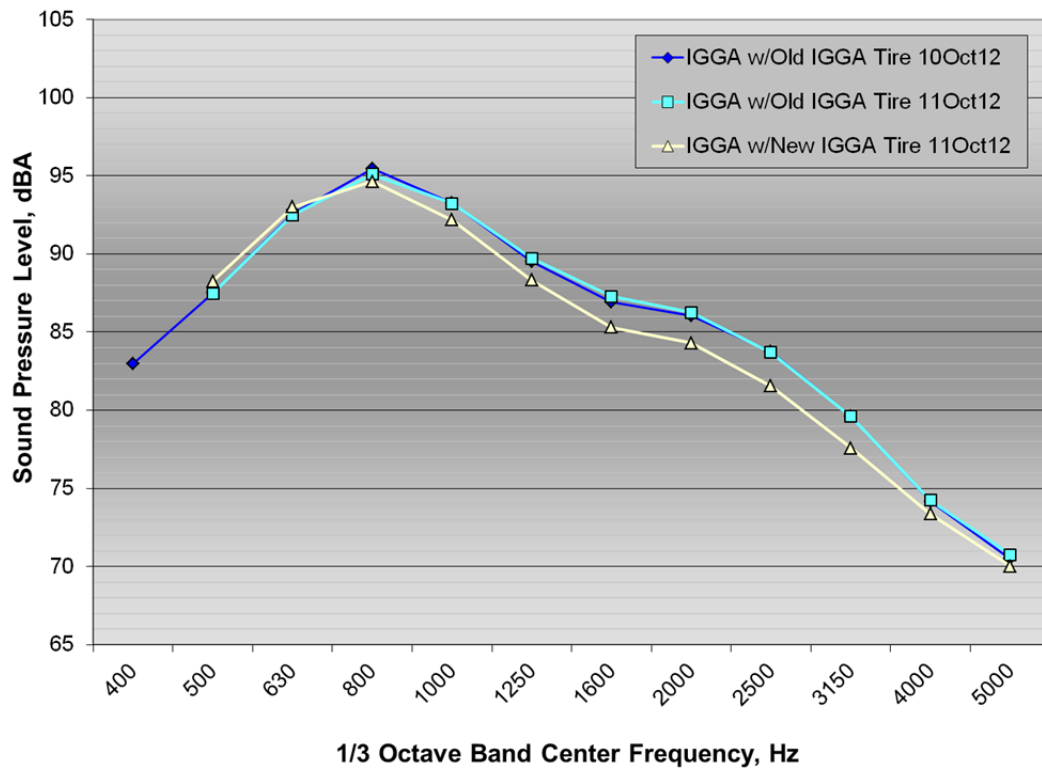
Figure 13: 1/3 octave band levels for old & new IGGA tires on Site 2 of Loop 2

the greater hardness of the older IGGA tire and its effect on the scrubbing mechanism [4,5]. The UC PRC tire also produced one-third octave band levels in the higher frequency bands that fell in between the Old IGGA tire and the NC Rodeo tire (see Figure 12) consistent with its hardness number being in between these other two tires. Figure 13 also provides an indication of test repeatability as the Old IGGA tire was tested on October 10th and 11th producing virtually identical results.
